# Inspection Report

**True Test Home Inspection**

| <b>Date:</b> 11/23/2015 | <b>Time:</b> | <b>Report ID:</b> Sample |

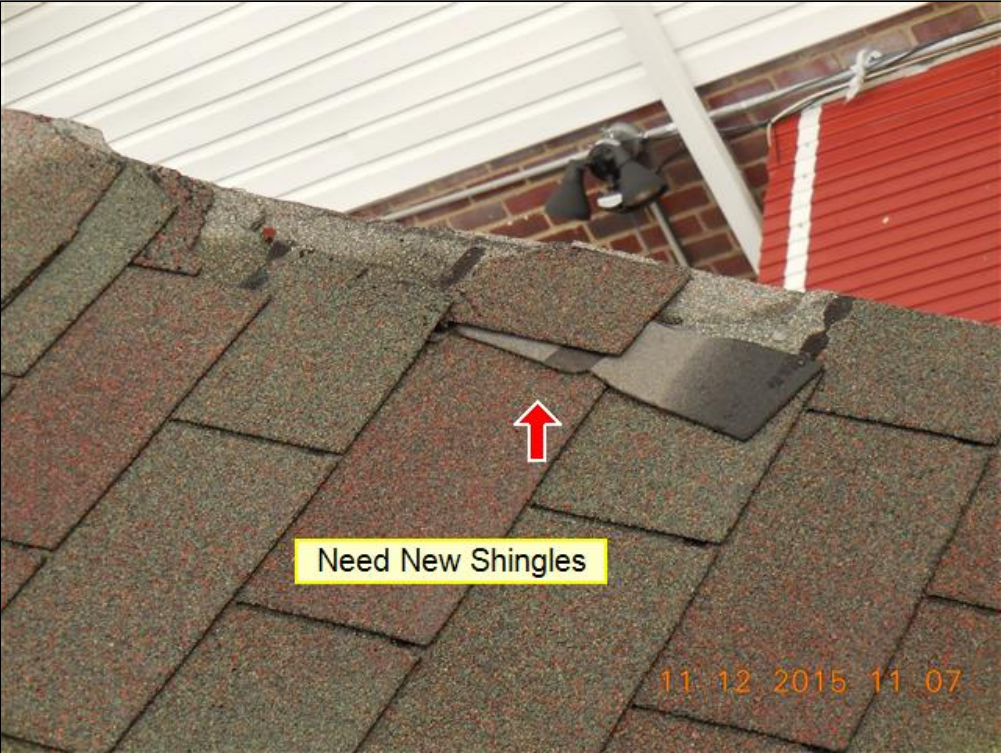
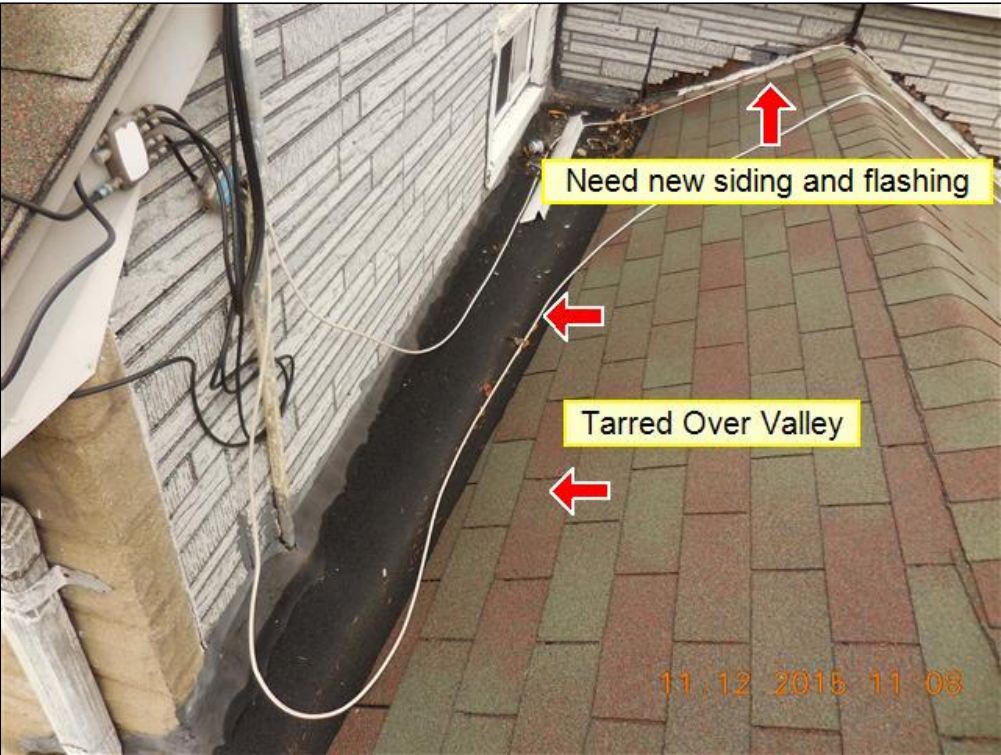
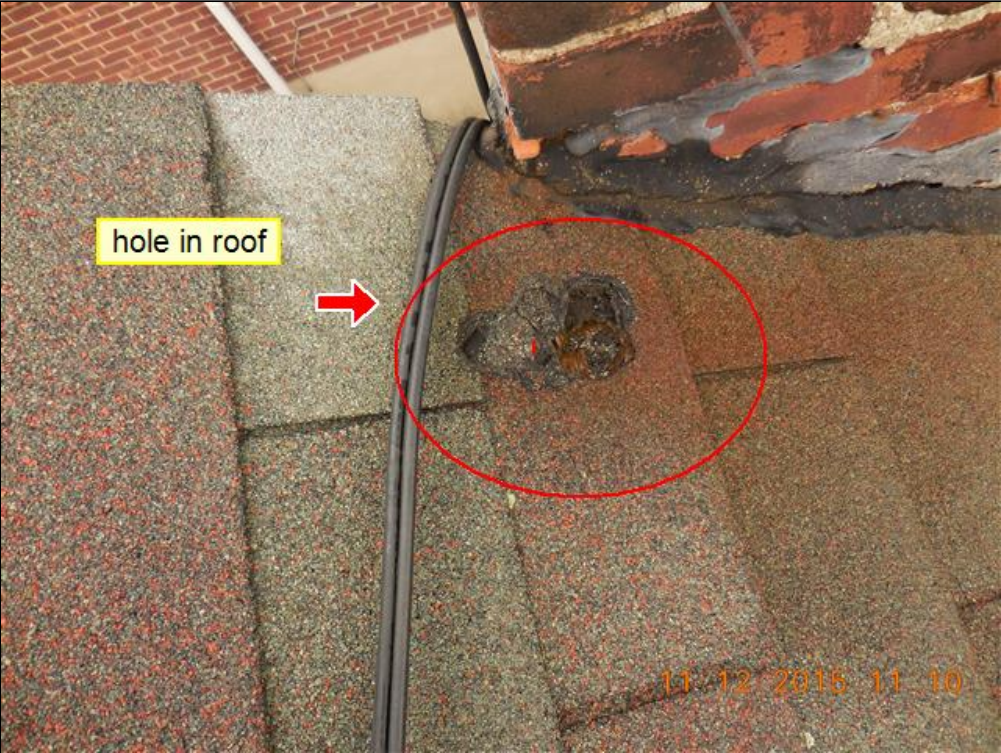
**1.0** This roof has 2 layers, some shingles are in need of repair, There is a hole in the roof and the valley over the garage where it meets the house has many layers of tar which indicates possible past and present leaks.

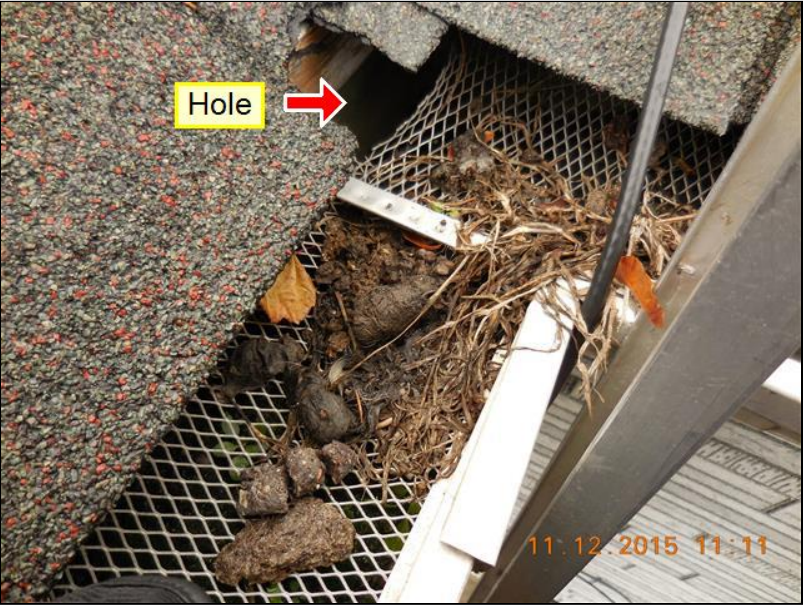
1.1 Item 1(Picture)

1.1 Hole in Fascia needs repair and gutters and down spouts need to be cleaned.

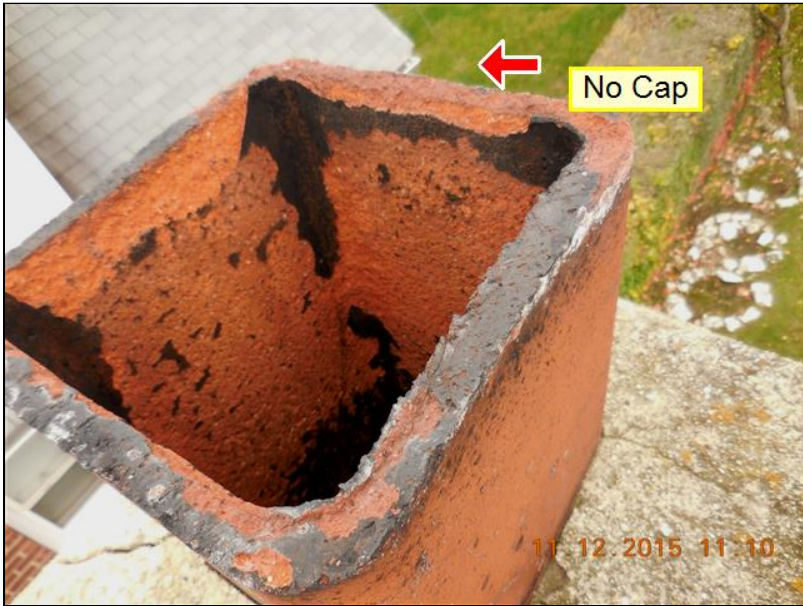
1.3 Item 1(Picture)

1.3 Chimney needs to be capped and vent is old rusted and not properly booted, (One probable cause of dampness in attic).

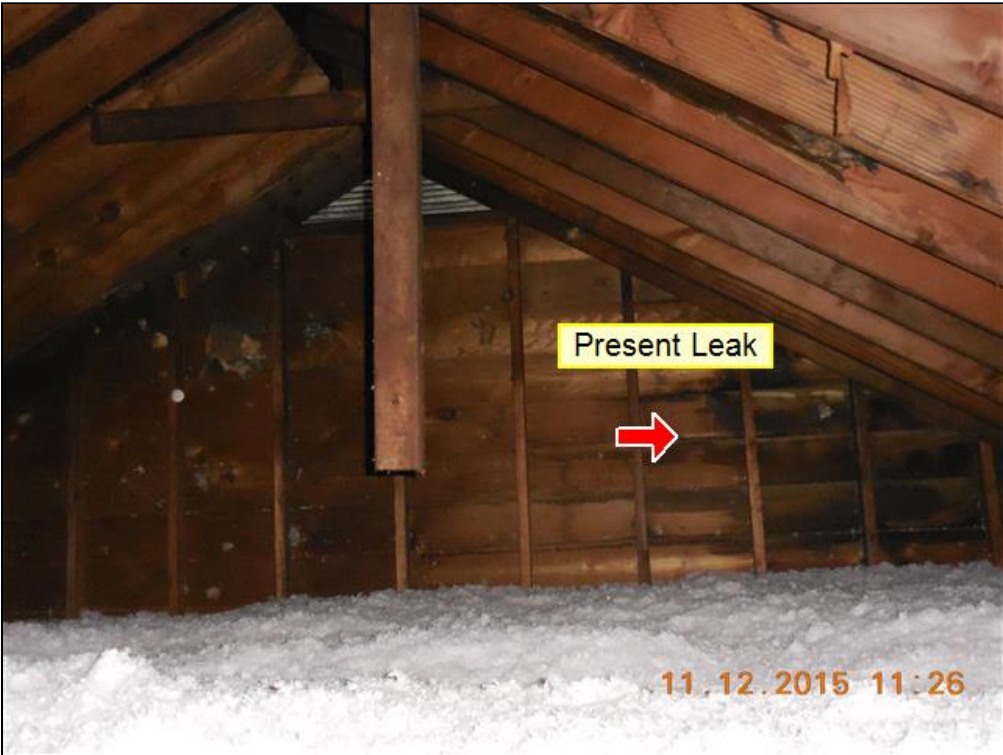
1.4 Item 1(Picture)

1.4 Attic has signs of past and present leaks and a very high moisture reading.

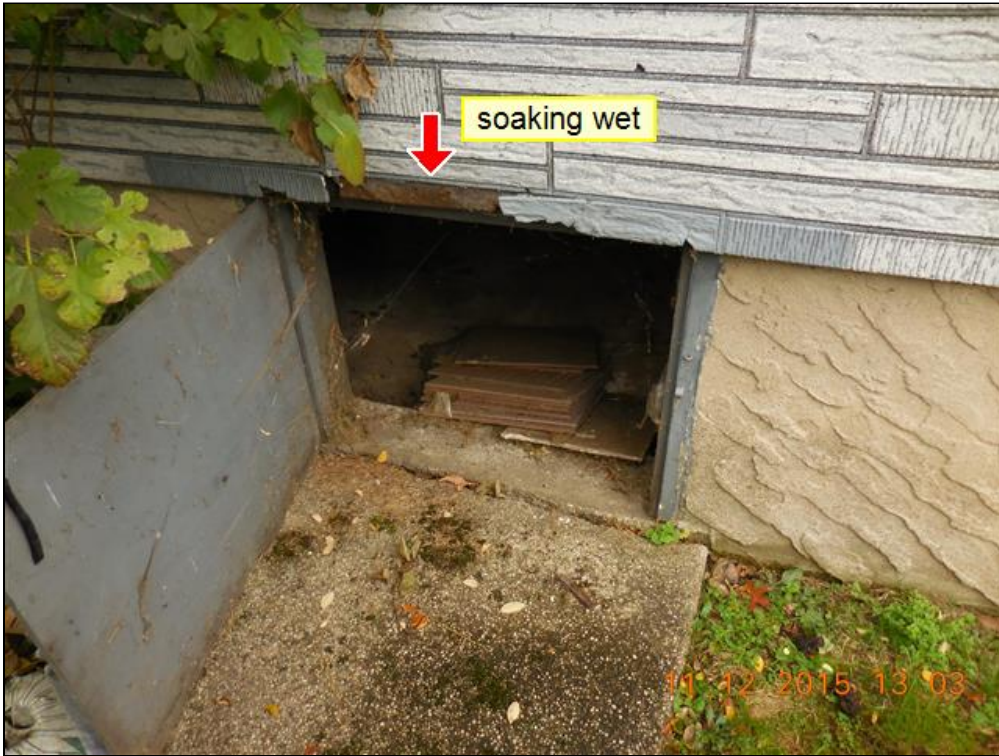
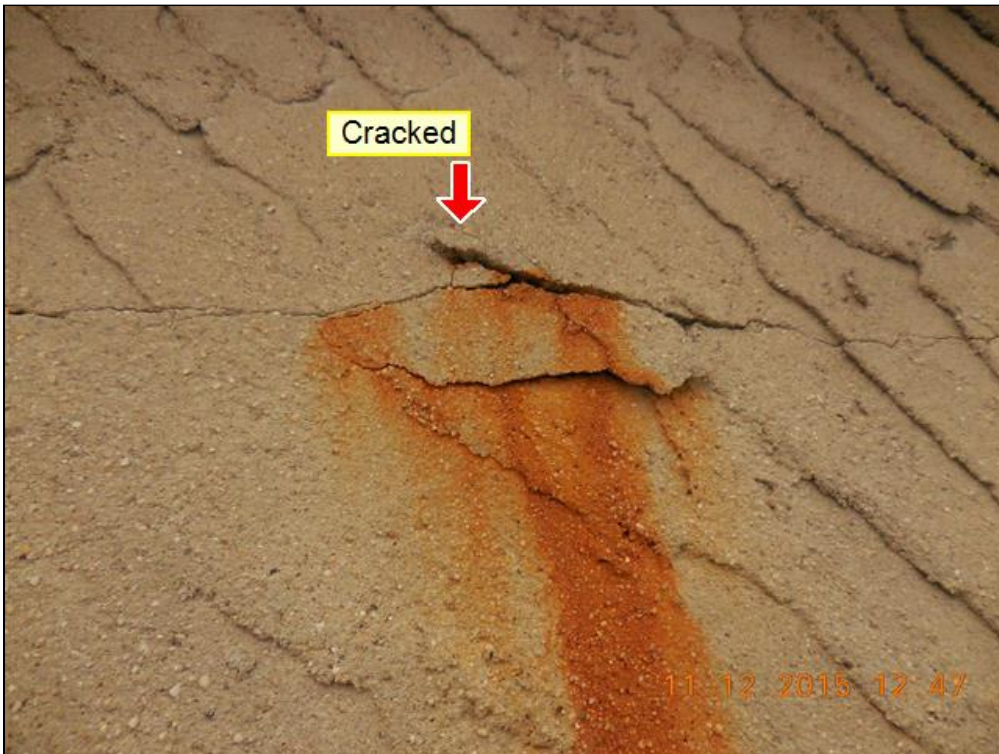
2.0 This wall cladding is problematic as it has compressed wood and cardboard underneath that retains water. The Asphalt coating is cracked and the lintel has rust underneath. I recommend replacing all asphalt sheet siding by a licensed contractor.

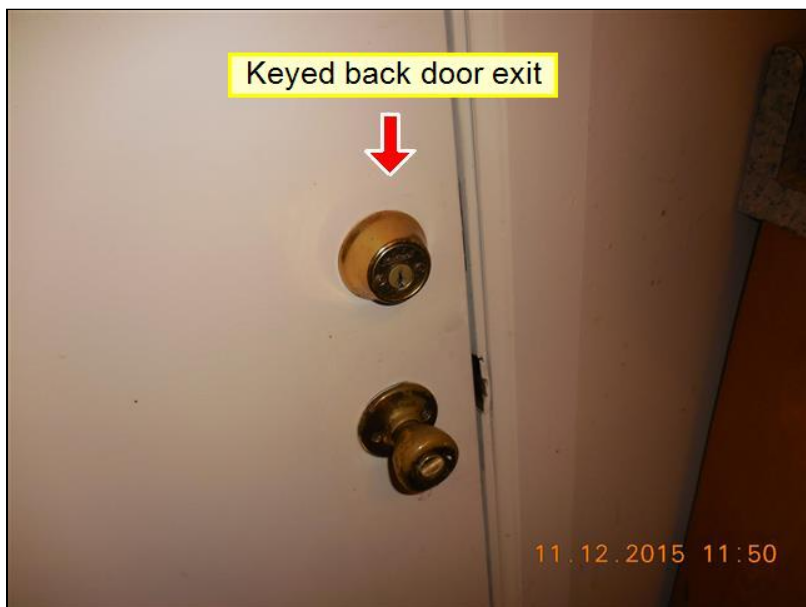
2.1 Item 1(Picture)

2.1 Rear door has interior key lock! This is a **Fire Safety Hazard!** The front metal door has damper broken.

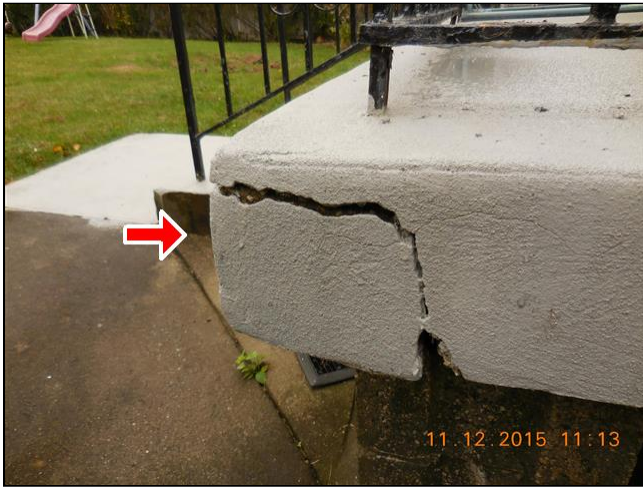
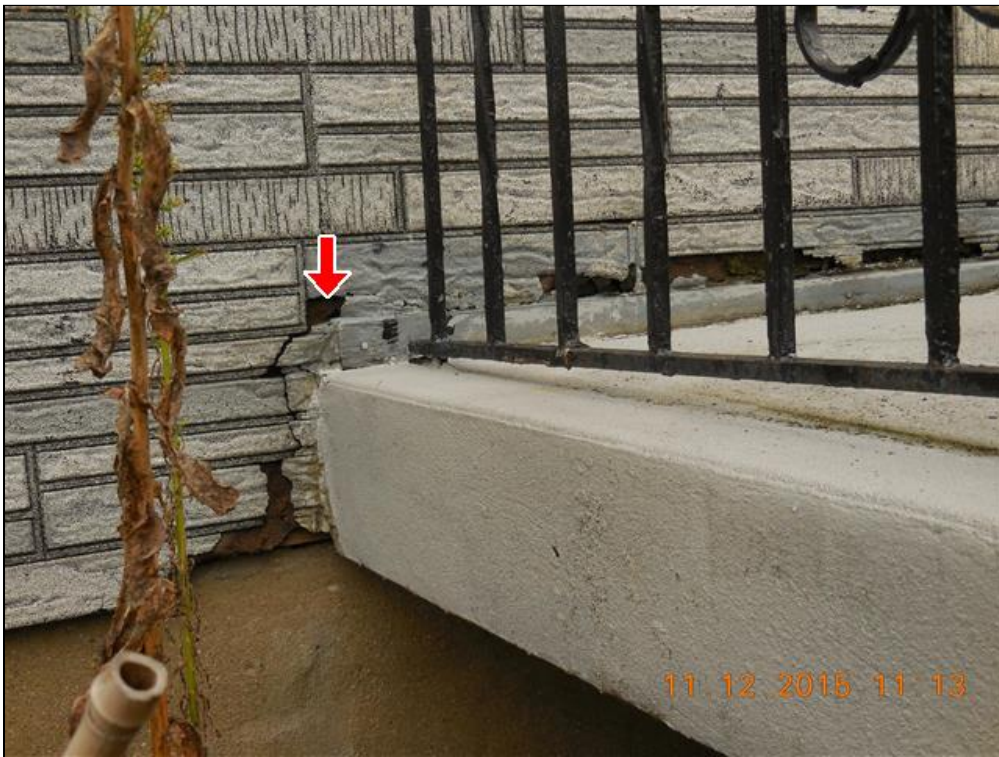
2.3 Steps and cement porch cracked and need repair. Porch pulling away from the dwelling.

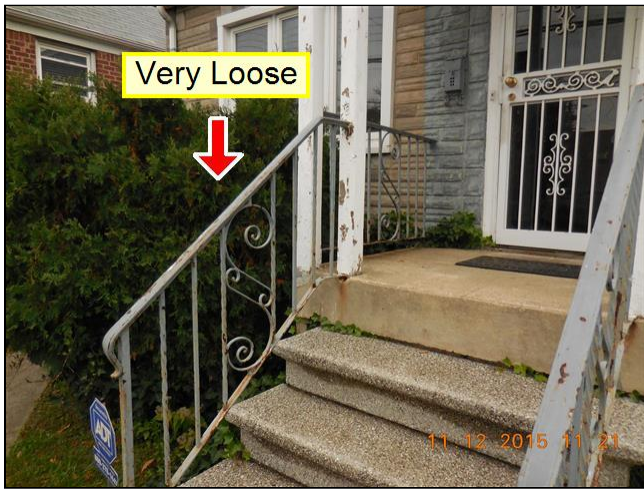
2.5 Item 1(Picture)

2.5 Front handrails very loose.

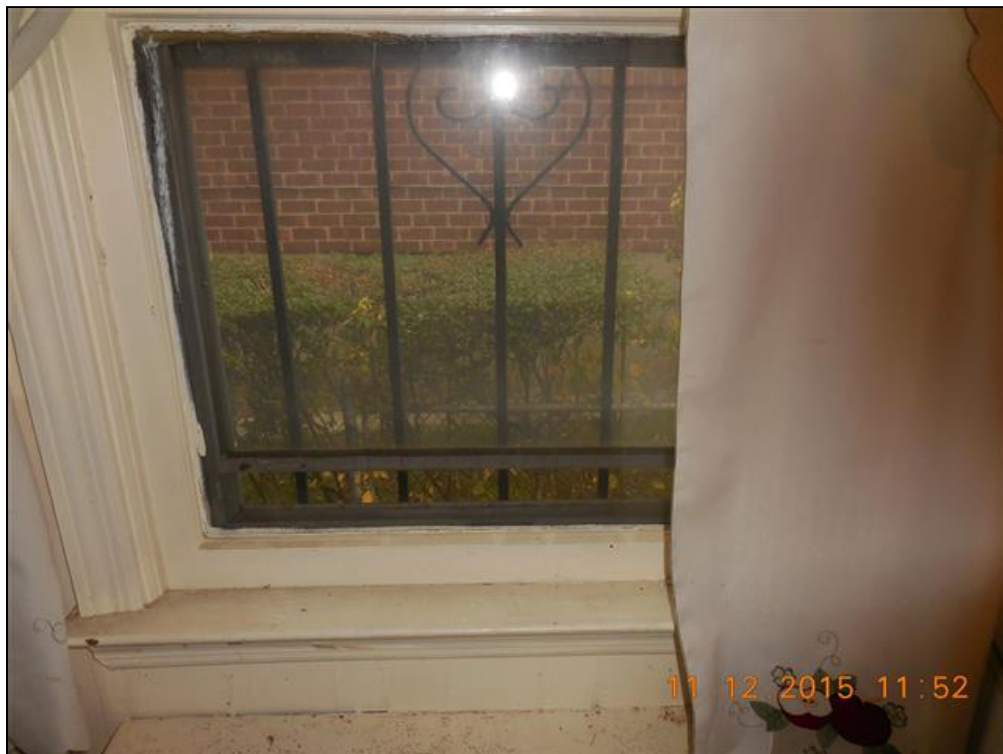
2.7 Item 1(Picture)

2.7 Windows are all old and cracked and all have bars that cannot be opened in an emergency. I recommend replacing all windows and removing all bars. **Fire Safety Hazard!**

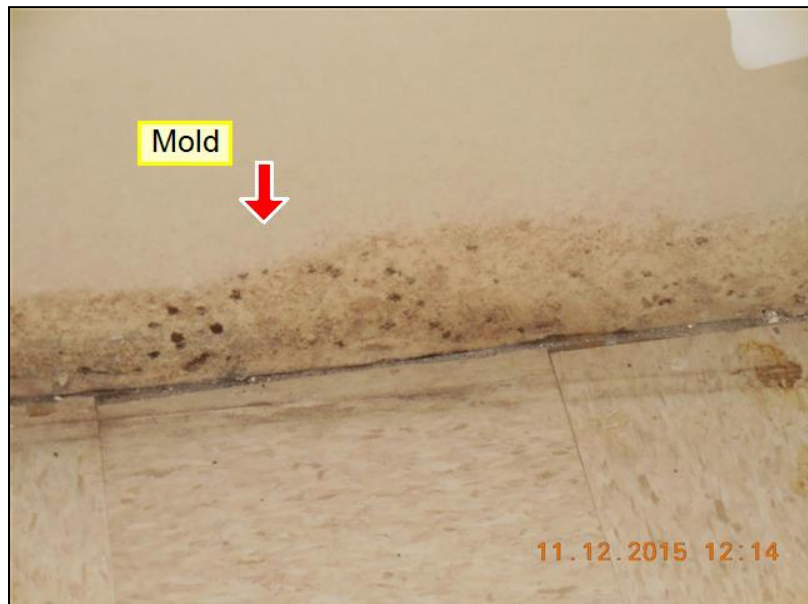
3.1 Item 1(Picture)

3.1 Walls were done unprofessionally and have signs of mold. There are huge holes and I recommend a licensed contractor repair and replace all Basement walls.

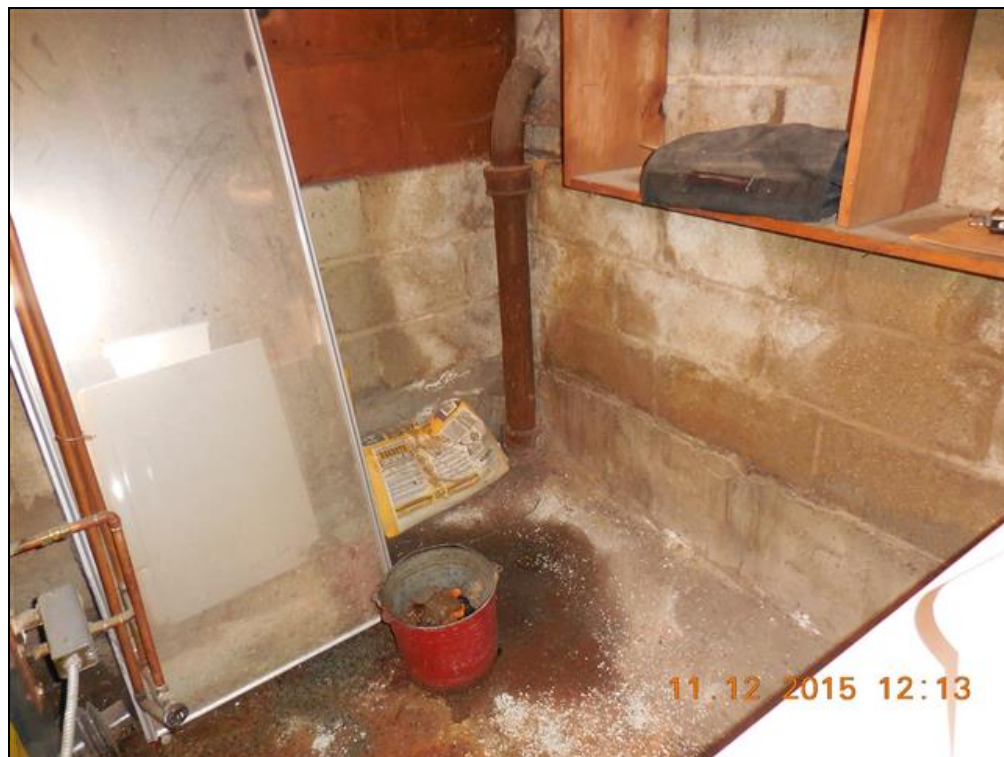
3.3 Item 1(Picture)

3.3 floors covered in an Past/Present oil leak

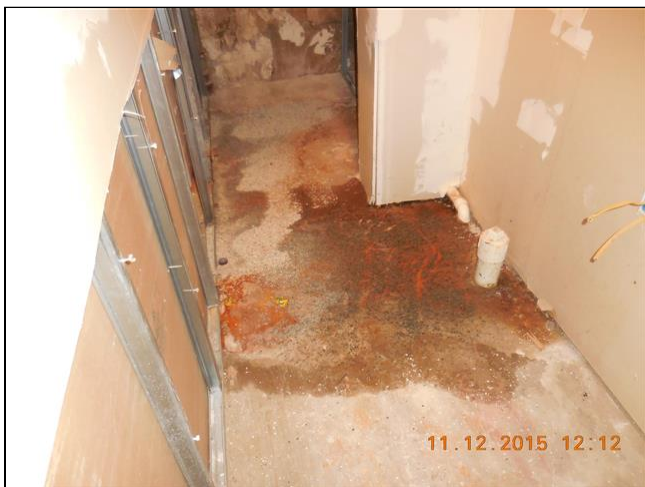
3.4 Item 1(Picture)

3.4 Walls and ceilings covered in sheetrock that was installed unprofessionally that all needs to be replaced!

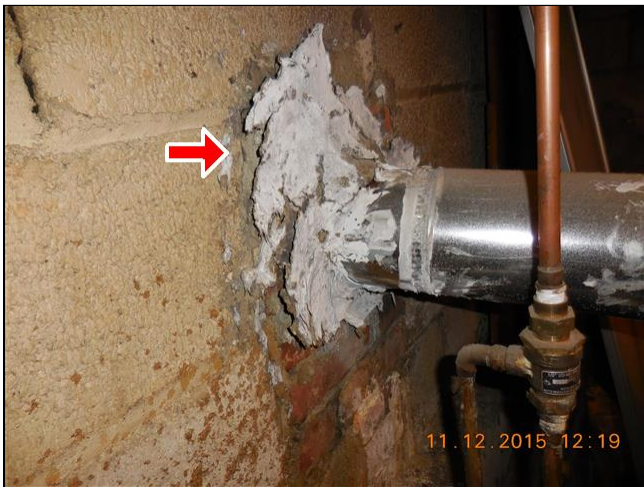
4.5 Item 1(Picture)

**4.5** Recommend repair by a licensed plumber. This vent not sealed properly.

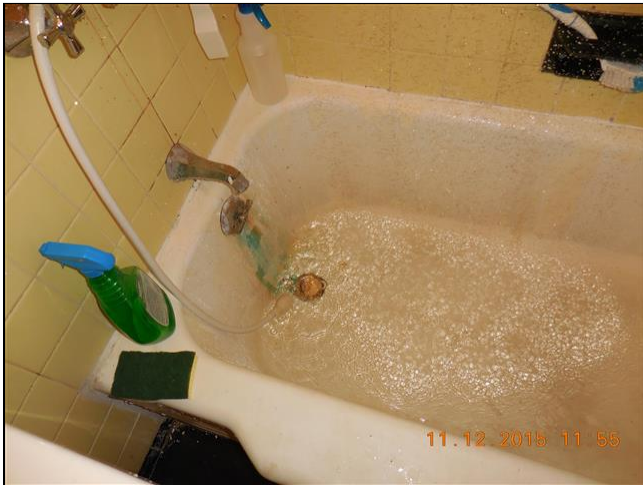
5.3 Item 1(Picture)

**5.3** All sinks not working properly and tub not draining properly. Tub also needs to be refinished, Kitchen sink does not have proper trap and slop sink not working. A Licensed plumber is recommended.

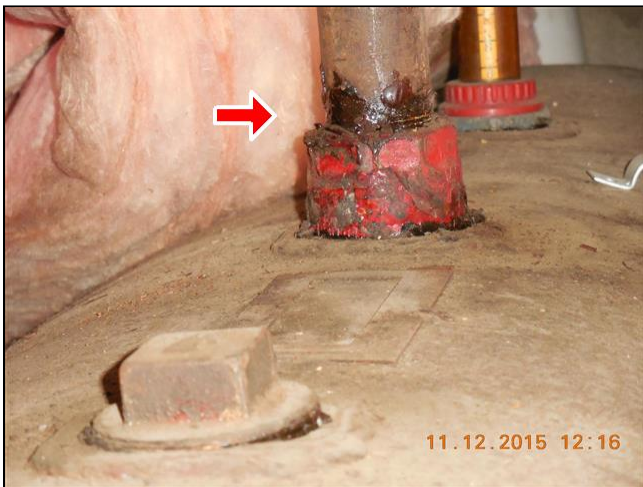
5.5 Item 1(Picture)

**5.5** Interior fuel storage is inaccessible behind a wall and has some apparent leaking up top.

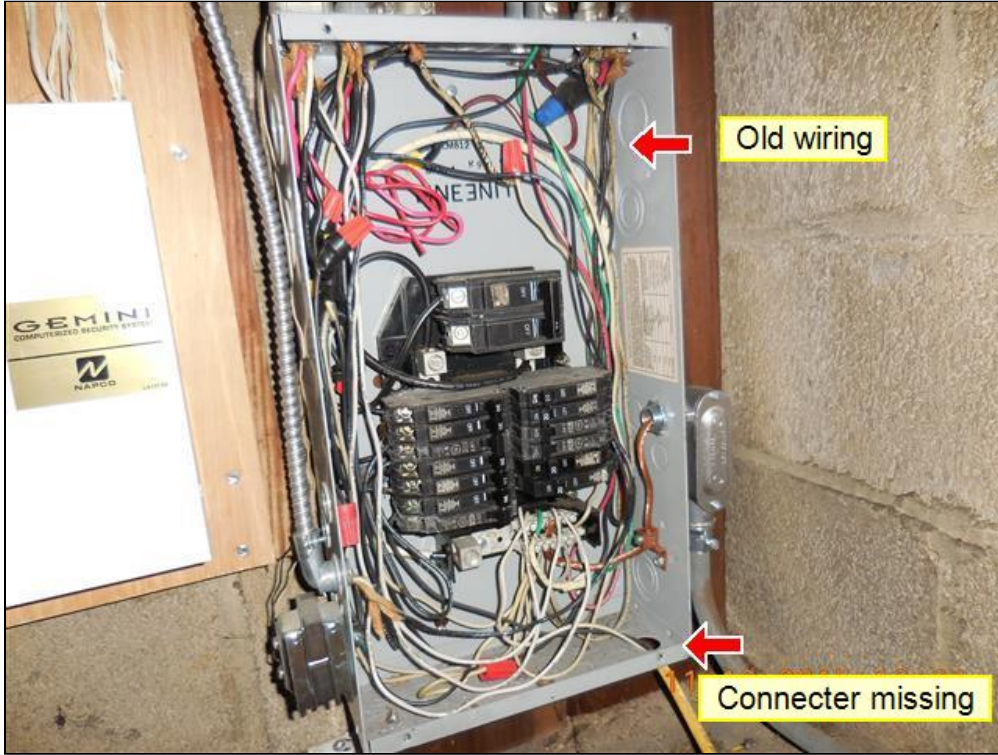
6.2 Item 1(Picture)

**6.2** This panel has ben worked on by an unlicensed electrician. Some of the old wiring still exists, some not marked correctly and basically shoddy workmanship deeming it unsafe.

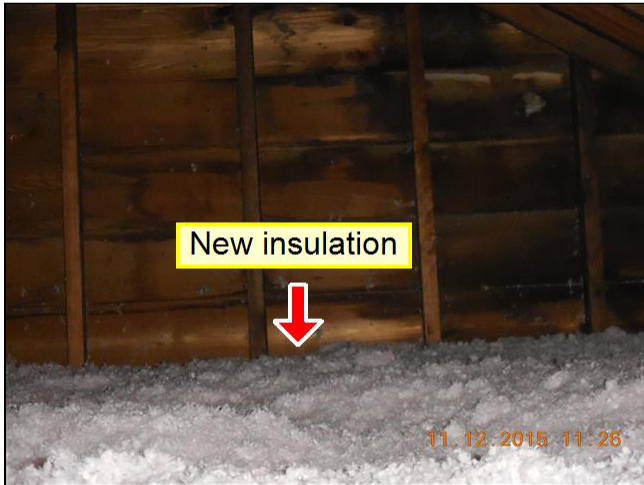
7.0 Item 1(Picture)

7.0 I believe this new insulation was blown in to cover up some bigger problems (mold,water damage).

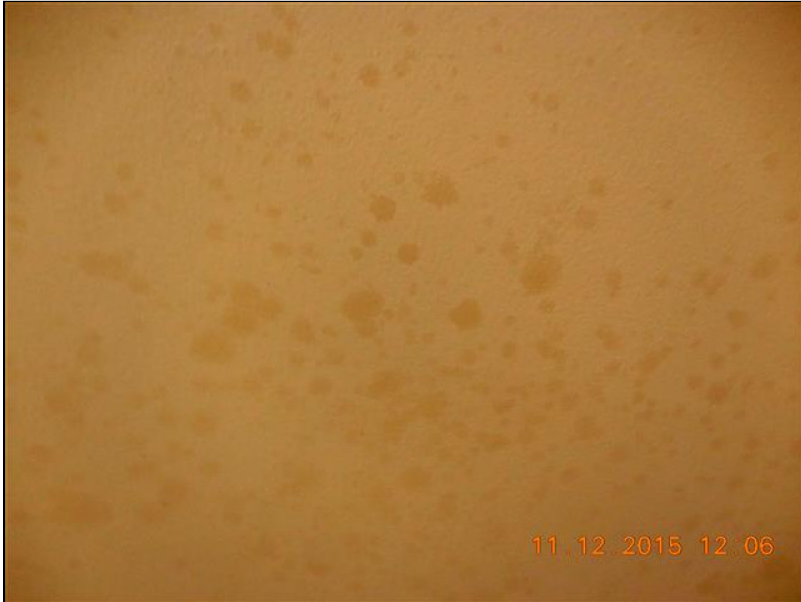
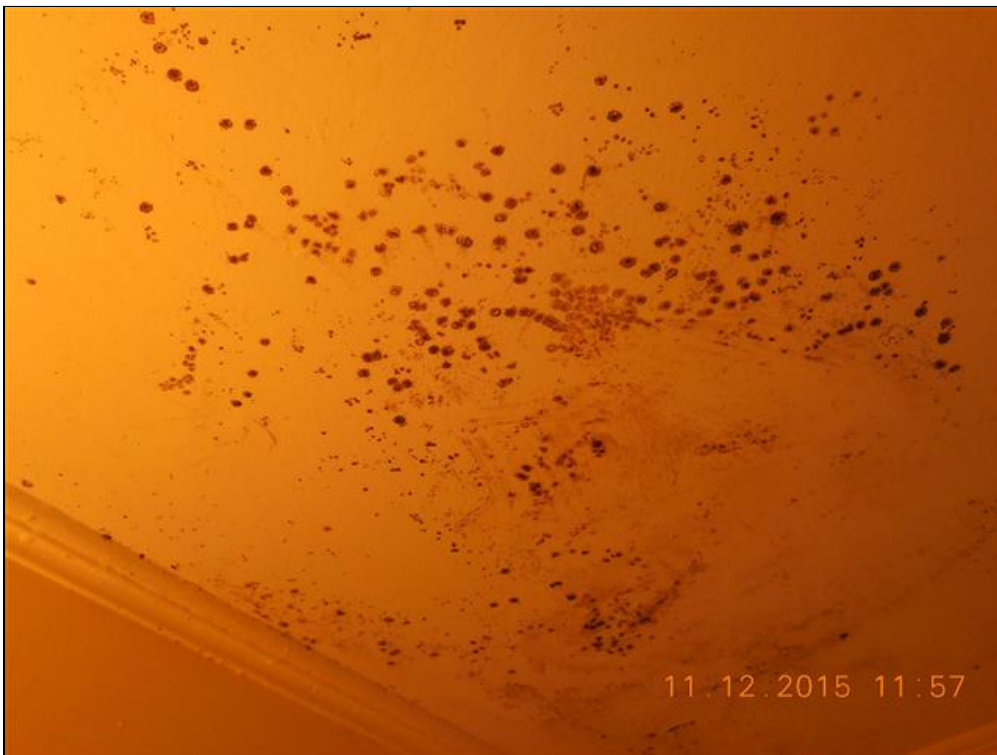
8.0 Active Mold present. Health hazard.

Presence of active Mold, Wood destroying Insects, (damage to structure unknown/covered), Rats, Mice. Buyer Beware.

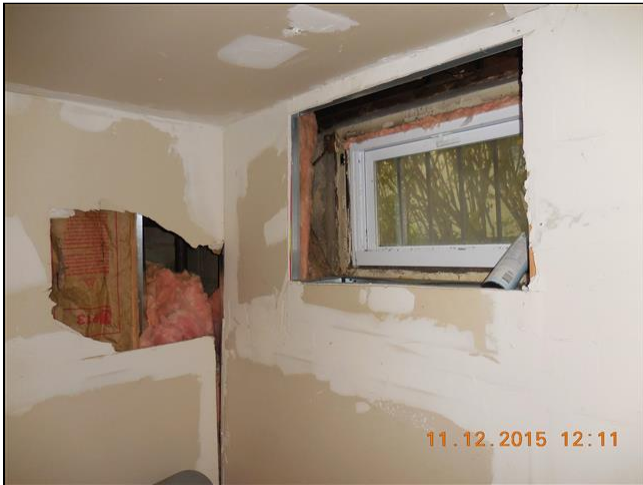
8.1 Item 1(Picture)

8.1 Unfinished walls and holes in basement, unprofessionally installed. 1st floor needs repairs and paint.

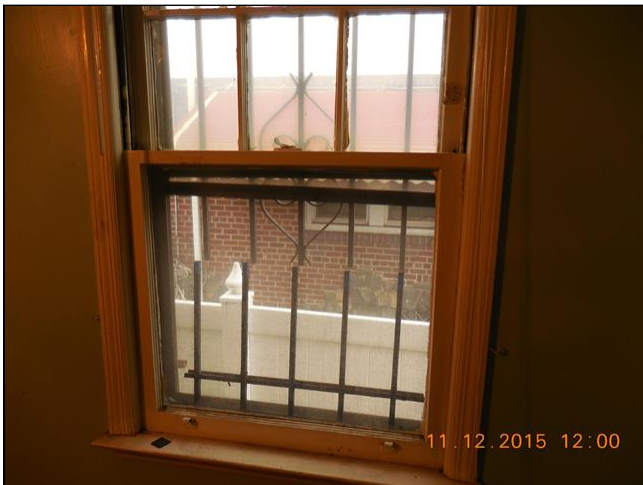
8.6 Item 1(Picture)

**8.6** Windows are old and are not rated for any efficiency. All windows have black bars which will impede evacuation in a fire situation. Unsafe!!

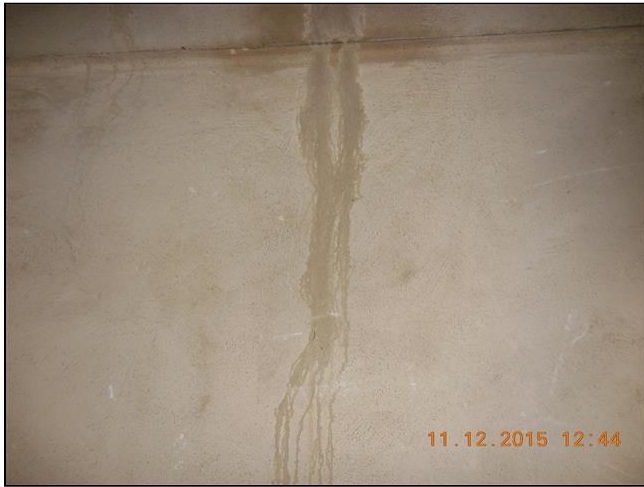
9.1 Item 1(Picture)

9.1 Leaks in garage and an unsafe window from garage to basement. This can lead to Co Poisoning. Beware!

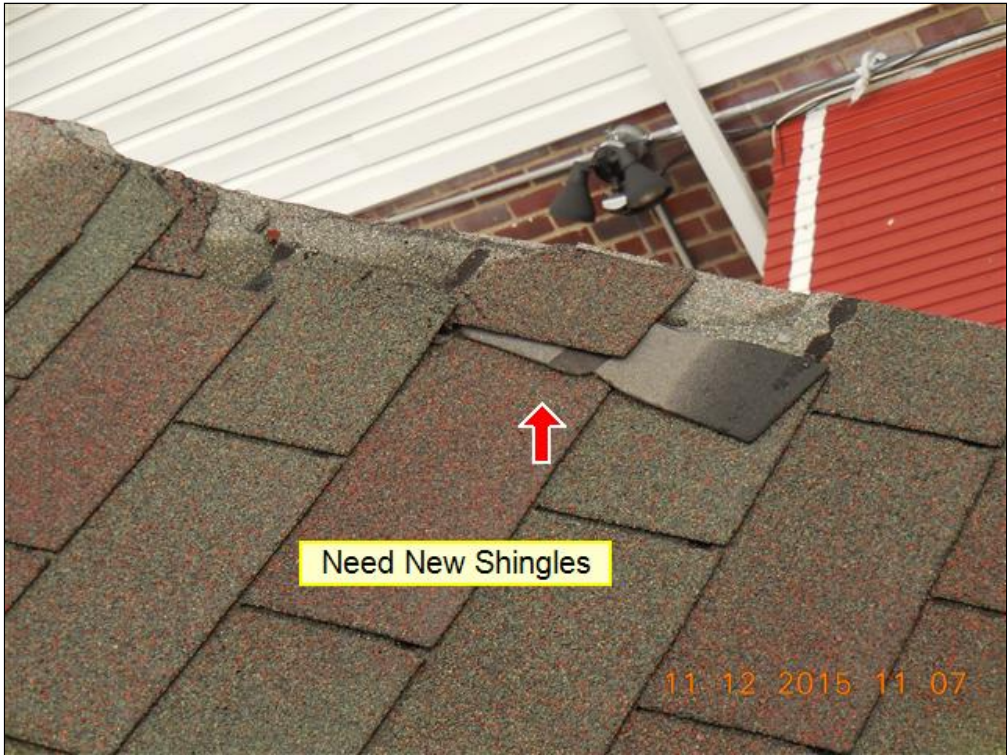
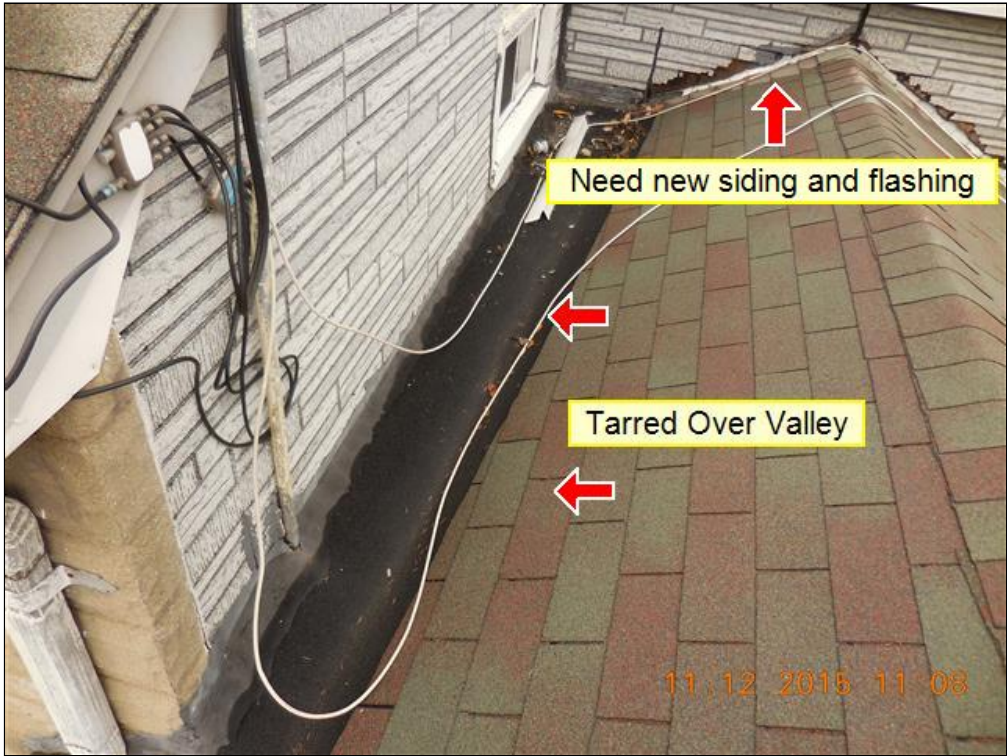
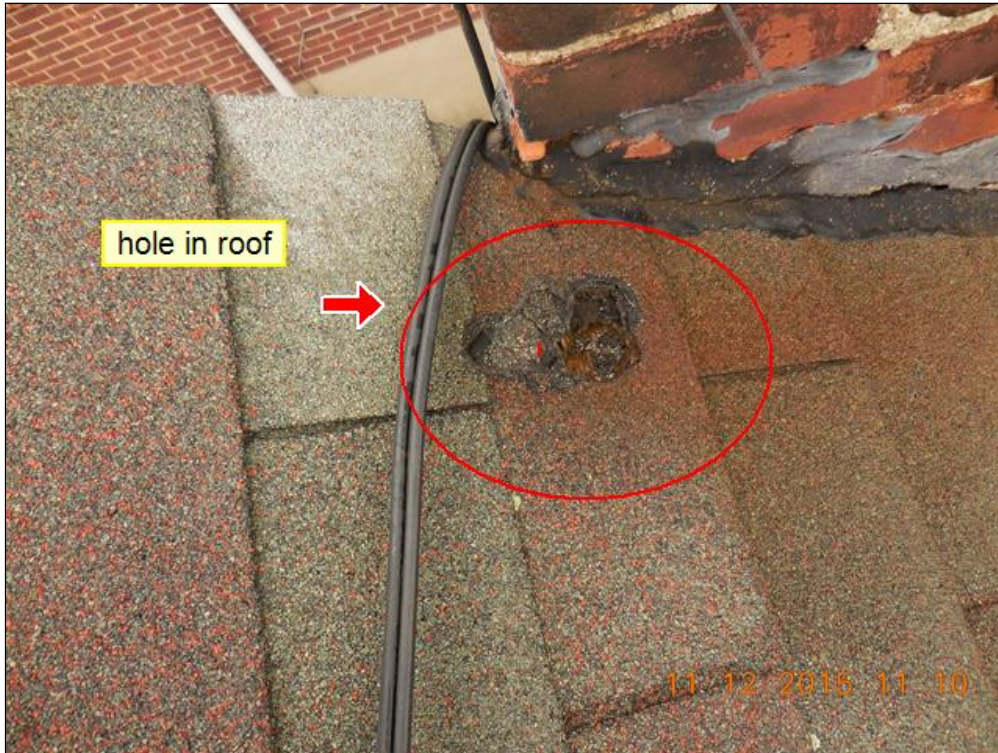
This roof has 2 layers, some shingles are in need of repair, There is a hole in the roof and the valley over the garage where it meets the house has many layers of tar which indicates possible past and present leaks.

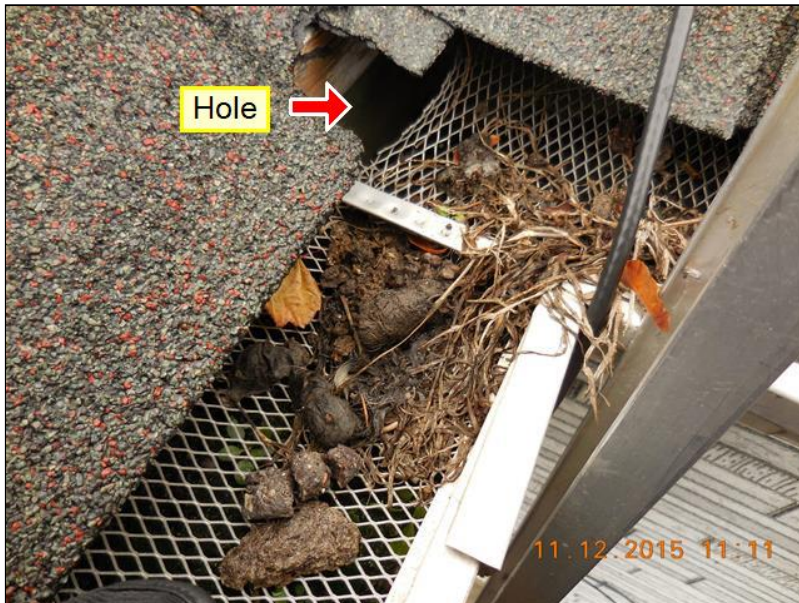
1.1 Item 1(Picture)

Hole in Fascia needs repair and gutters and down spouts need to be cleaned.

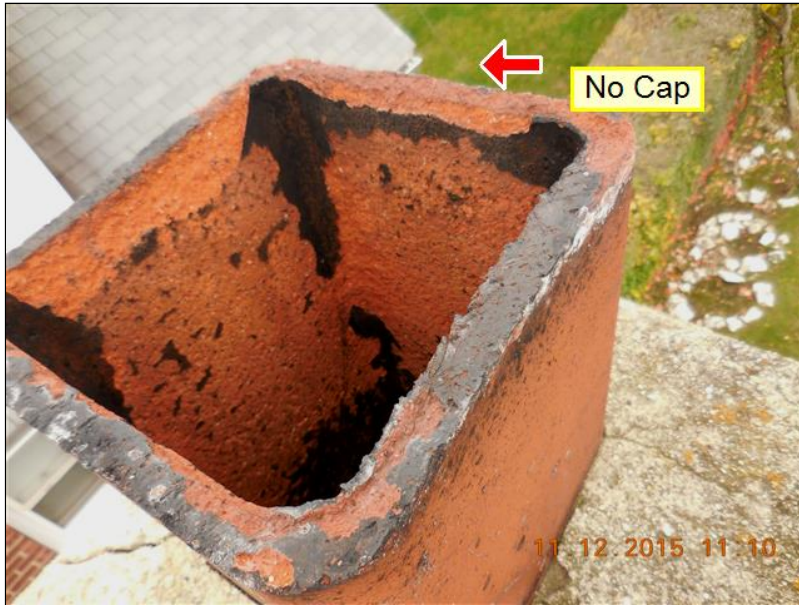
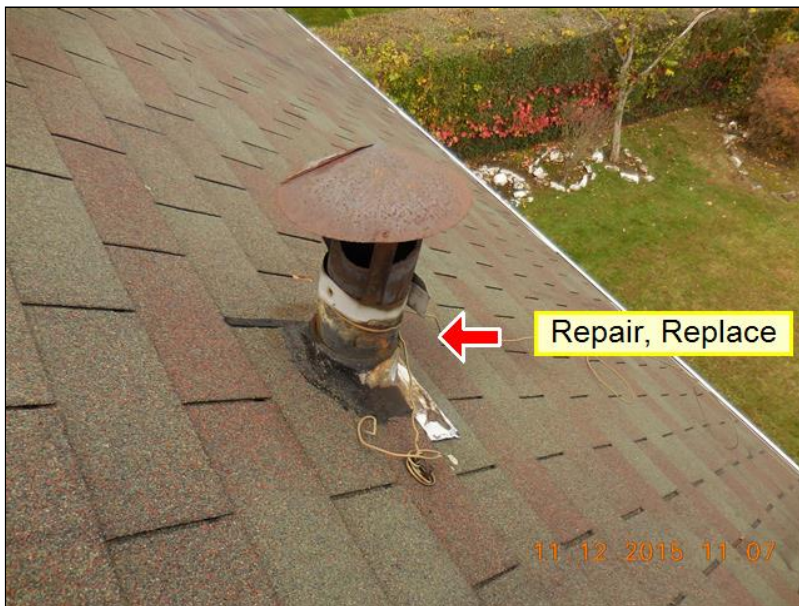
Chimney needs to be capped and vent is old rusted and not properly booted, (One probable cause of dampness in attic).

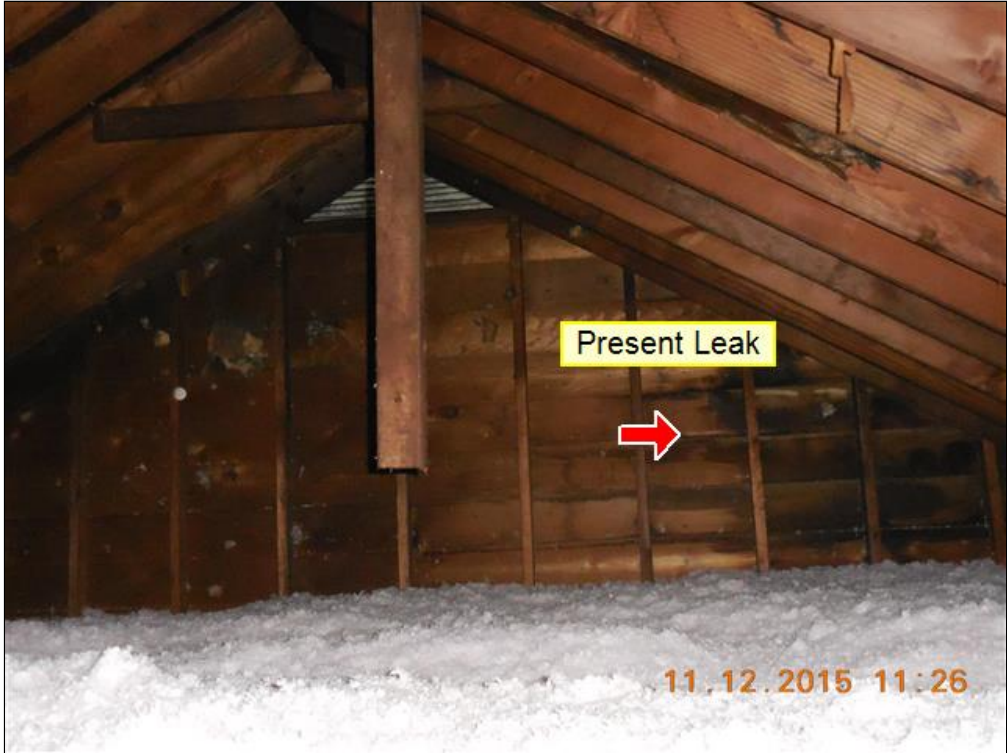
1.4 Item 1(Picture)

Attic has signs of past and present leaks and a very high moisture reading.

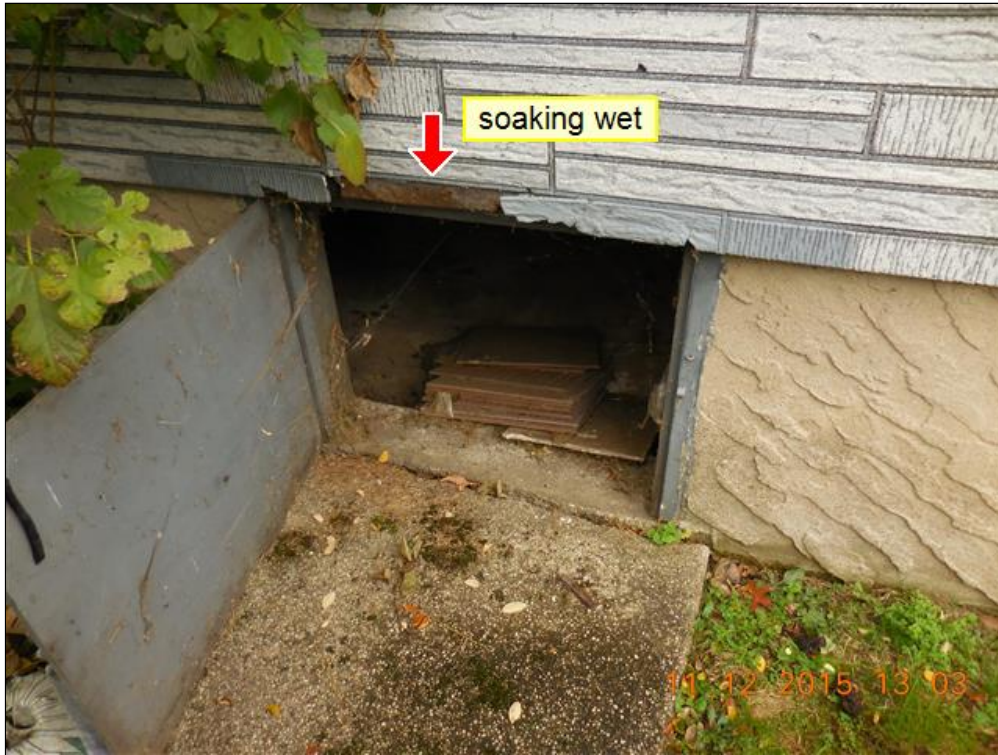
2.0 Item 1(Picture)

This wall cladding is problematic as it has compressed wood and cardboard underneath that retains water. The Asphalt coating is cracked and the lintel has rust underneath. I recommend replacing all asphalt sheet siding by a licensed contractor.

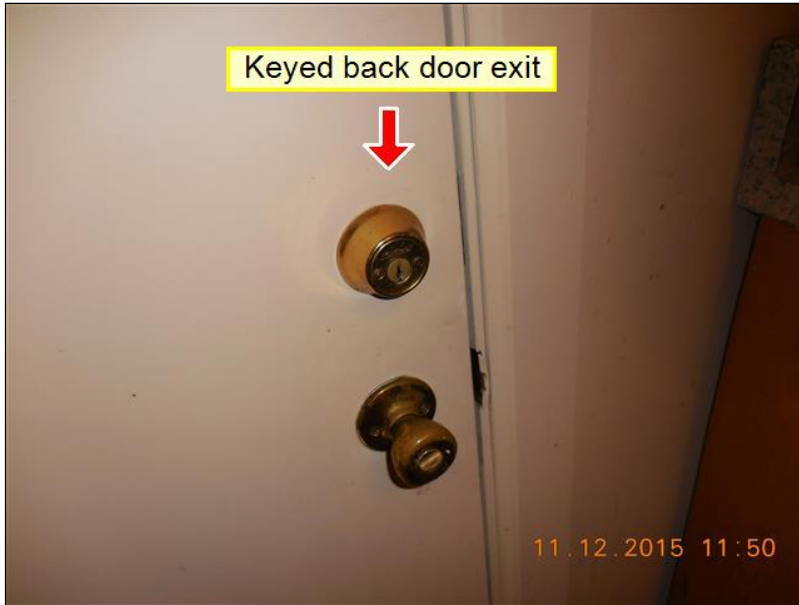
2.1 Item 1(Picture)

Rear door has interior key lock! This is a **Fire Safety Hazard!** The front metal door has damper broken.

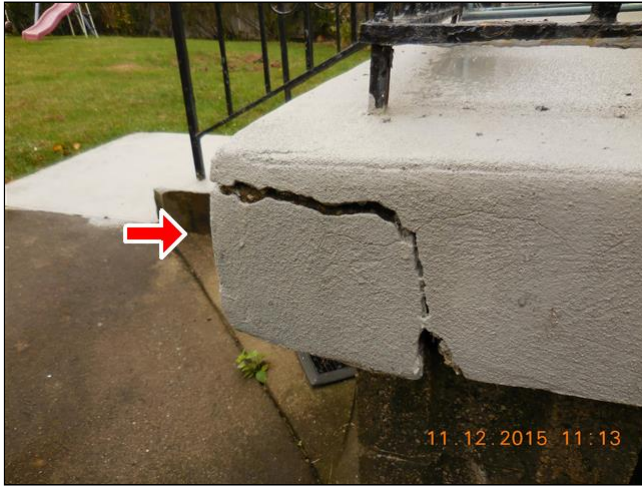
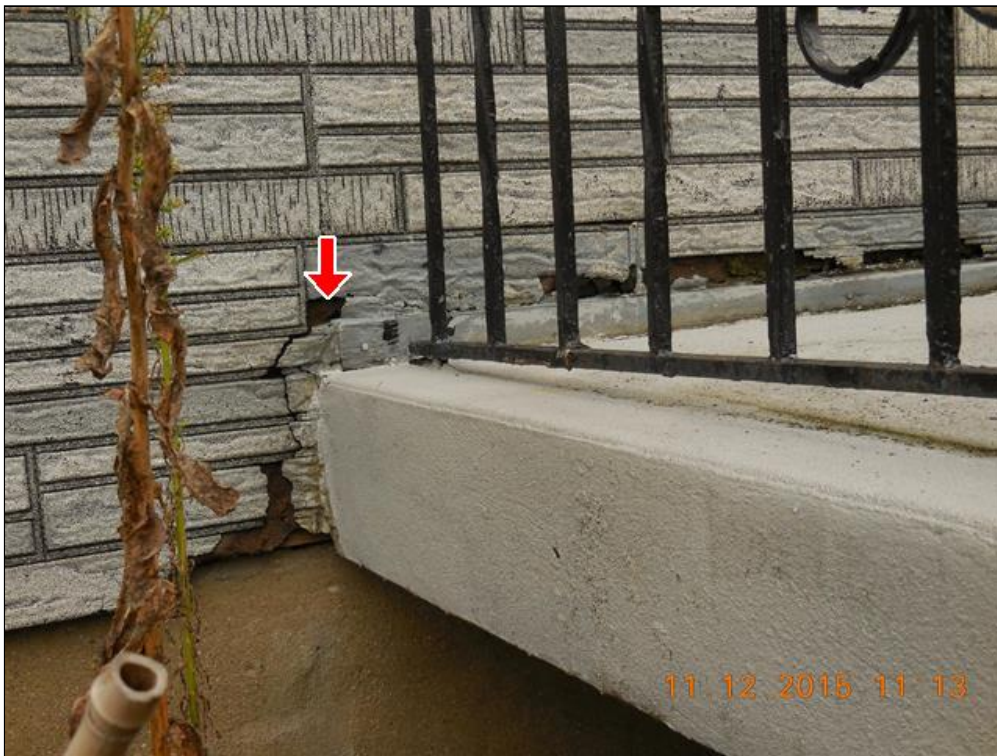
Steps and cement porch cracked and need repair. Porch pulling away from the dwelling.

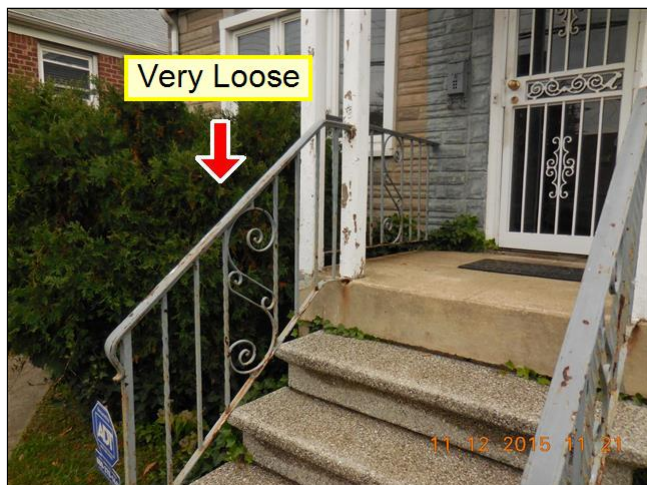
2.5 Item 1(Picture)

Front handrails very loose.

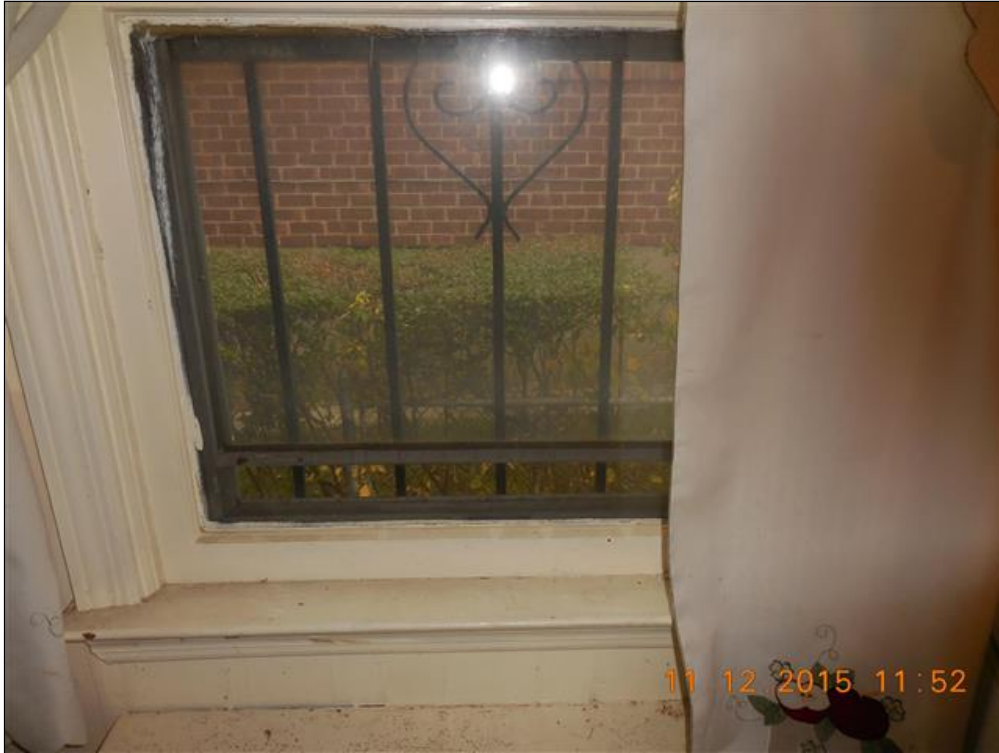
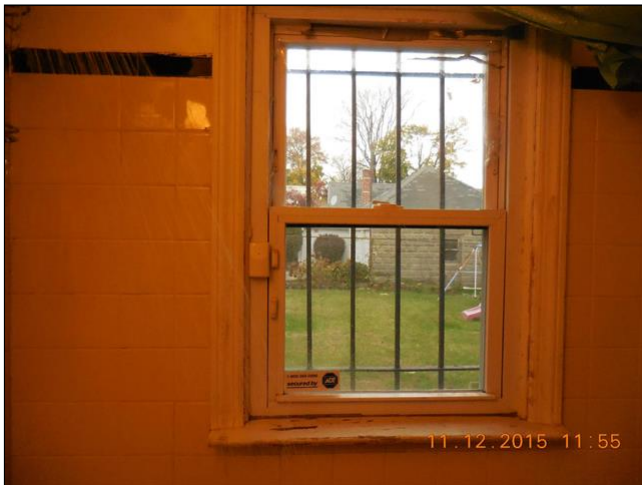
Windows are all old and cracked and all have bars that cannot be opened in an emergency. I recommend replacing all windows and removing all bars. **Fire Safety Hazard!**
