# Inspection Report

**True Test Home Inspection**

| <b>Date:</b> 11/23/2015 | <b>Time:</b> | <b>Report ID:</b> Sample |

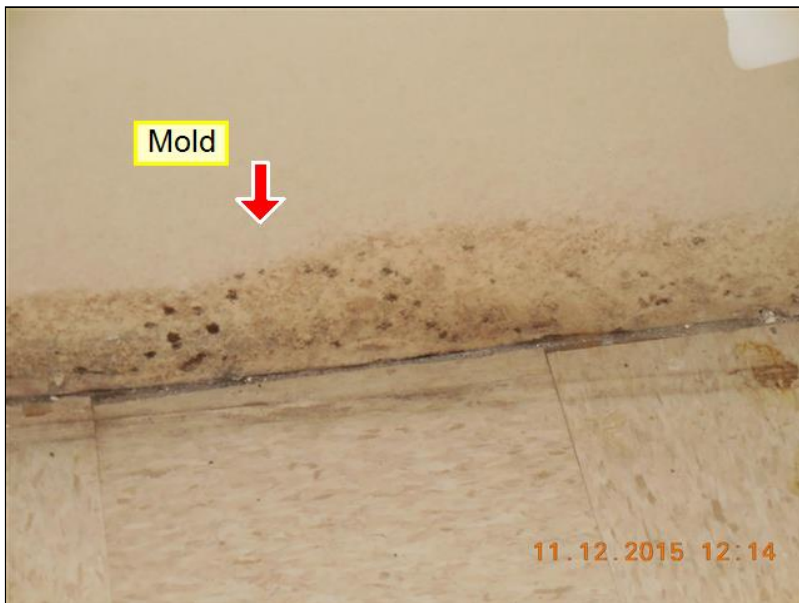
3.1 Item 1(Picture)

Walls were done unprofessionally and have signs of mold. There are huge holes and I recommend a licensed contractor repair and replace all Basement walls.

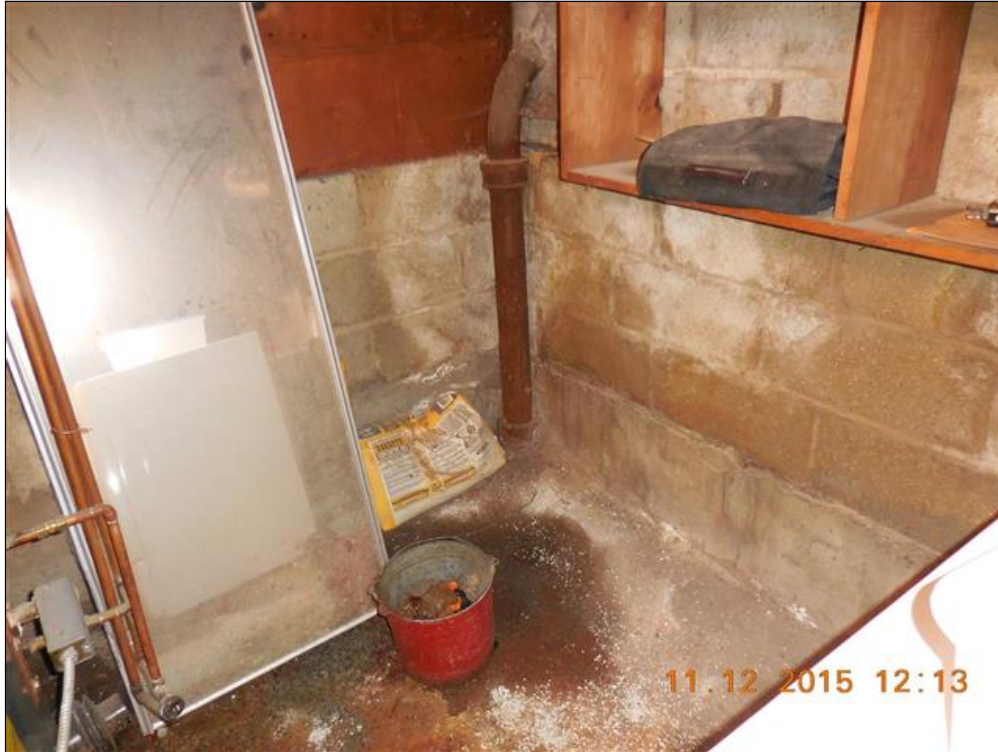
3.3 Item 1(Picture)

floors covered in an Past/Present oil leak

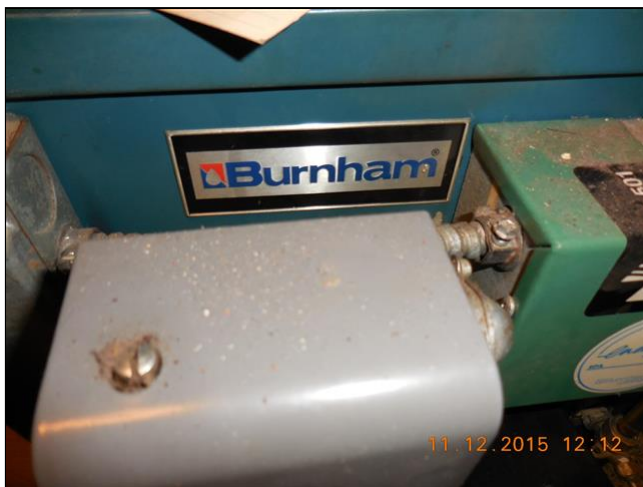
4.0 Item 1(Picture)

Not Working or hooked up. Oil spilled all over floor, Toxic fumes, Buyer Beware!

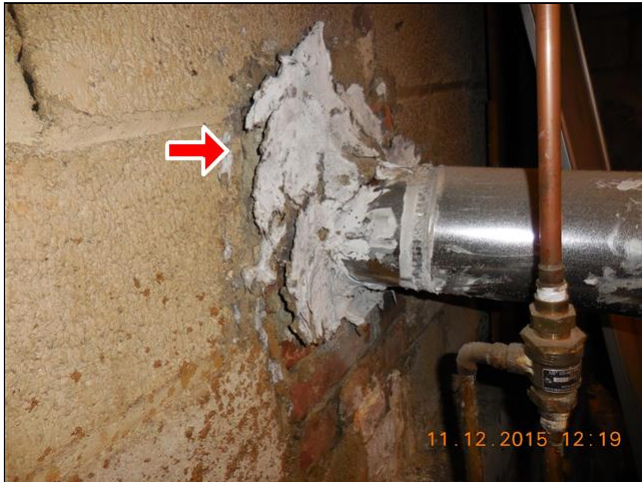
4.5 Item 1(Picture)

Recommend repair by a licensed plumber. This vent not sealed properly.

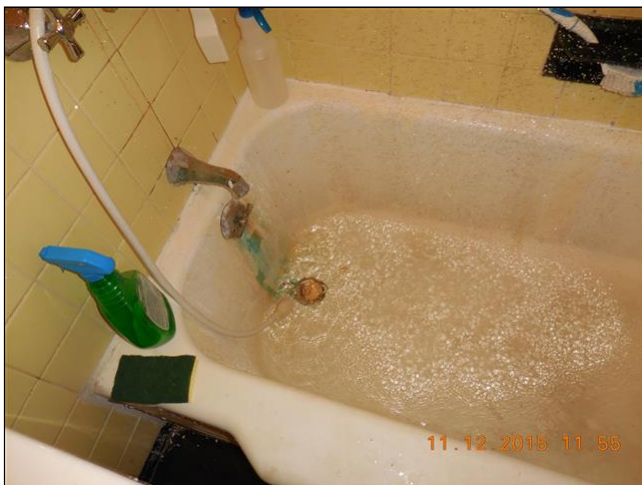
5.3 Item 1(Picture)

All sinks not working properly and tub not draining properly. Tub also needs to be refinished, Kitchen sink does not have proper trap and slop sink not working. A Licensed plumber is recommended.

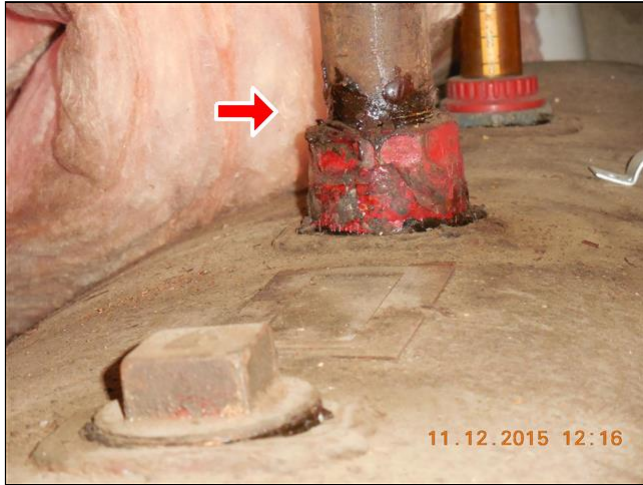
5.5 Item 1(Picture)

Interior fuel storage is inaccessible behind a wall and has some apparent leaking up top.

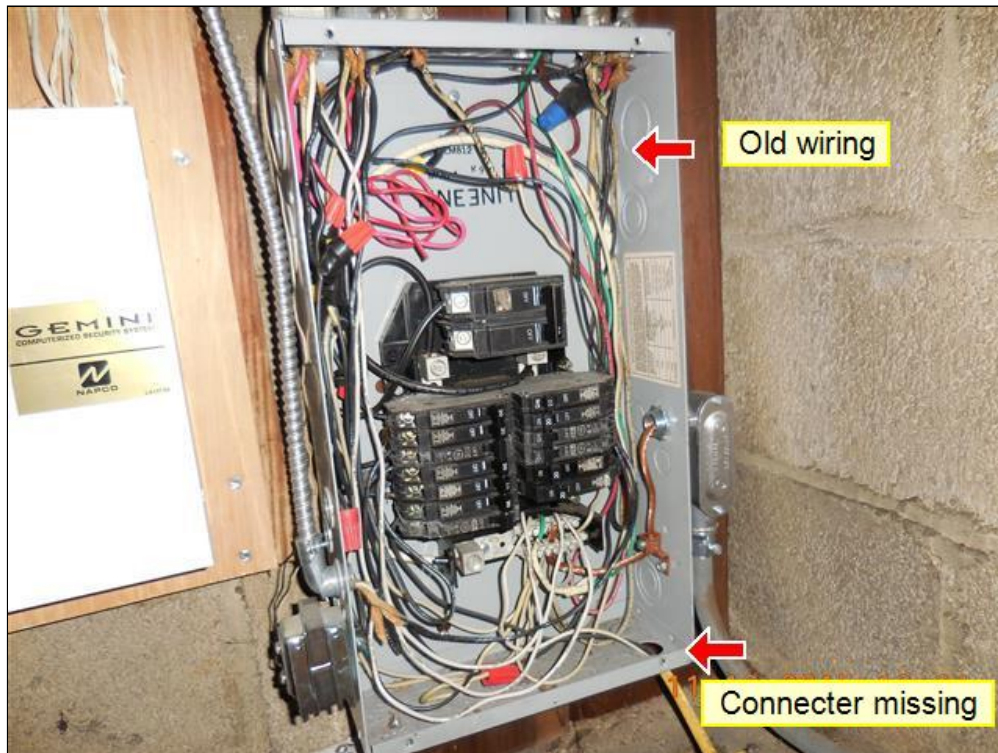
6.2 Item 1(Picture)

This panel has been worked on by an unlicensed electrician. Some of the old wiring still exists, some not marked correctly and basically shoddy workmanship deeming it unsafe.

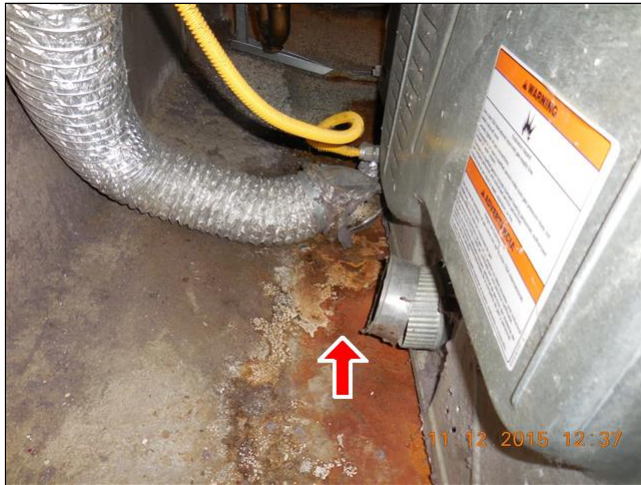
7.4 Item 1(Picture)

Not connected

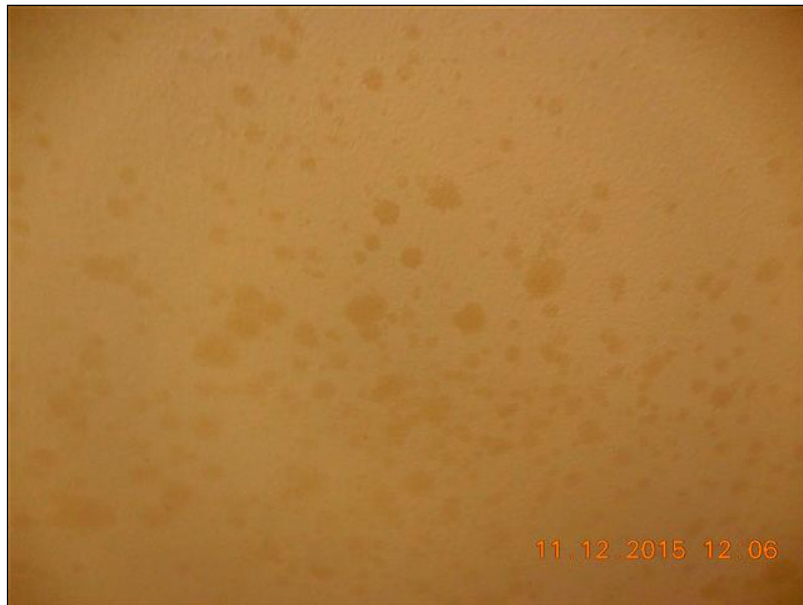
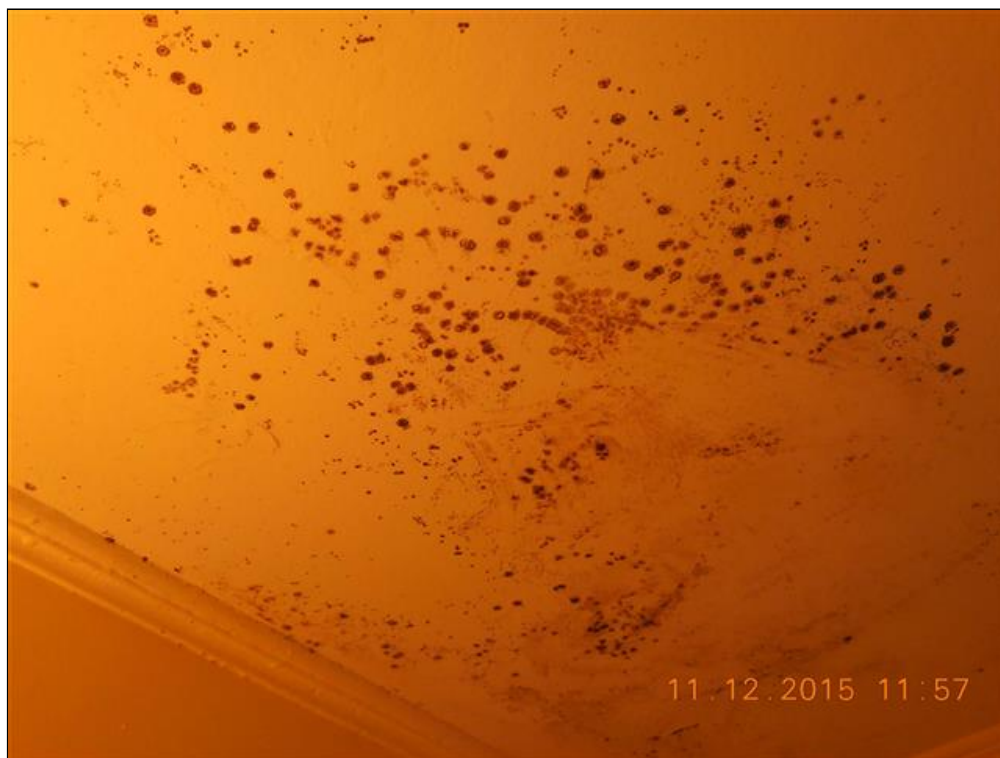
Active Mold present. Health hazard.

Presence of active Mold, Wood destroying Insects, (damage to structure unknown/covered), Rats, Mice. Buyer Beware.

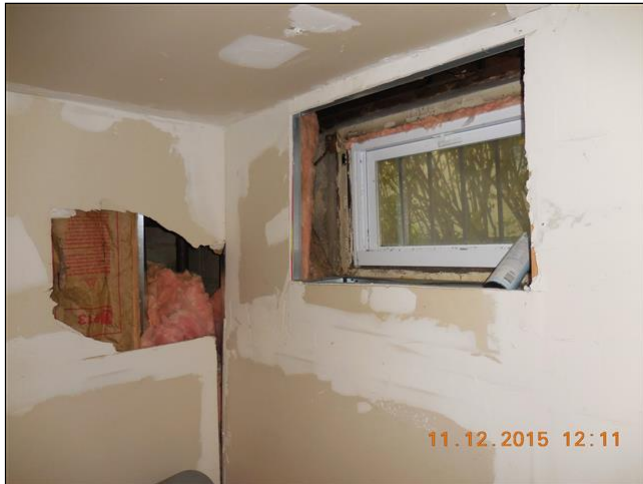
8.1 Item 1(Picture)

Unfinished walls and holes in basement, unprofessionally installed. 1st floor needs repairs and paint.

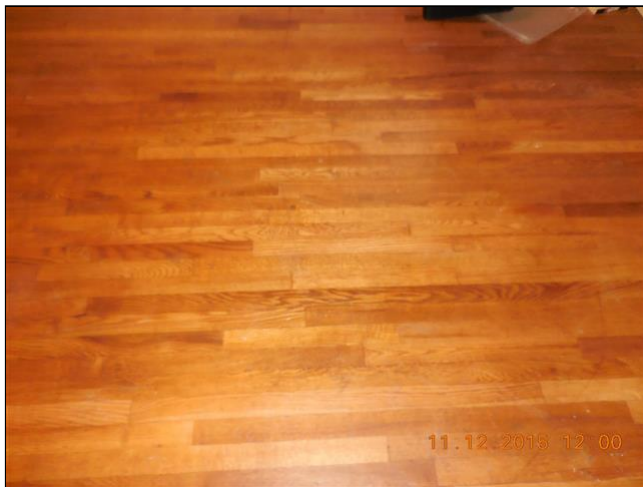
8.2 Item 1(Picture)

Need to be refinished.

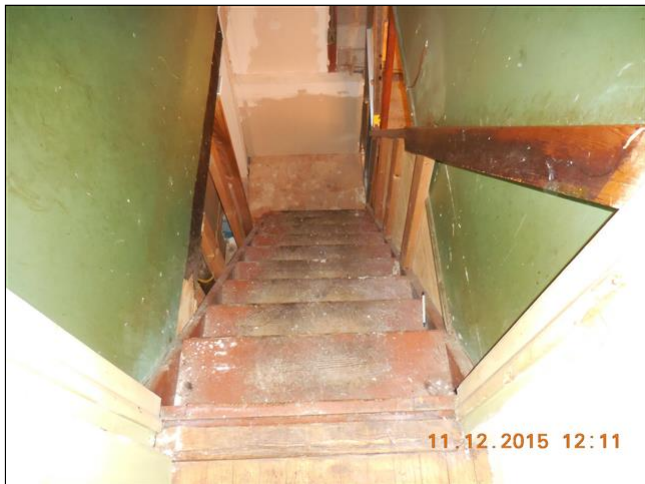
8.3 Item 1(Picture)

Needs work.

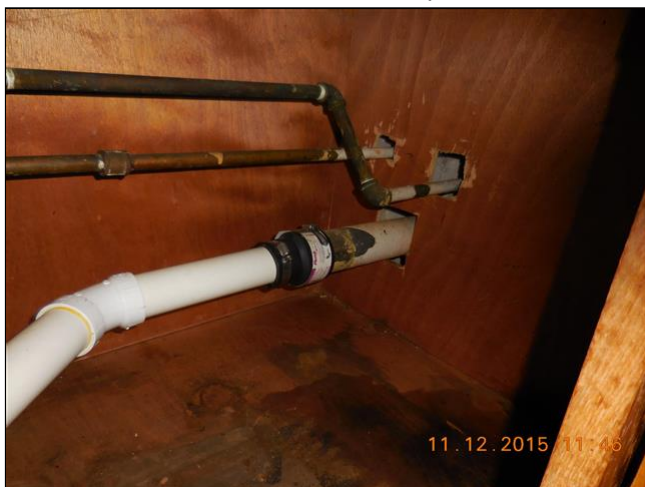
8.4 Item 1(Picture)

Holes and counter broken. Needs replacement.

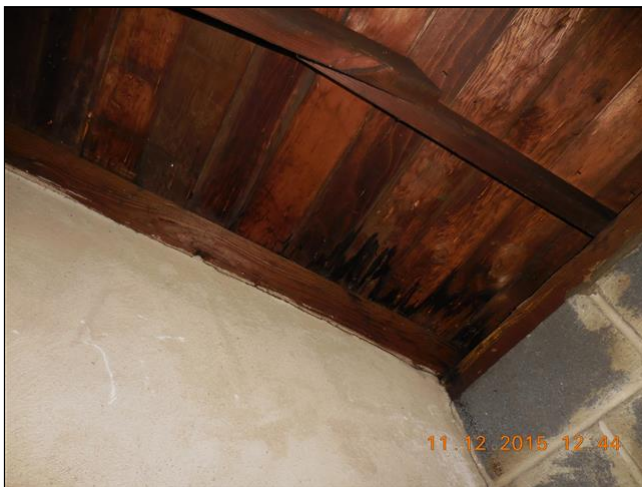
9.0 Item 1(Picture)

Garage has present signs of water penetration and has a window from the garage to the basement that can induce dangerous CO poisoning into basement.
